DUFFY HOME INSPECTION SERVICE, INC.

DATE OF INSPECTION: 0-00-2006.
TIME OF INSPECTION: 12:30 noon.
CLIENT NAME: Mr. Mat Jones.
PHONE #: 404-000-5555.
E-MAIL ADDRESS: euwww@comcast.com.

000 Jones Drive.

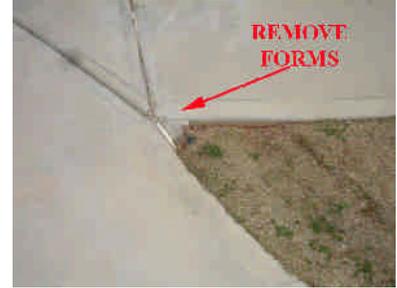
DRIVE CONDITION: 1. Remove all the 1x4 forms, right side (top).
2. Cracks noted are typical, recommend monitoring all cracks in the future. *Note: I recommend you monitor for voids in the future (especially next to the garage area).*

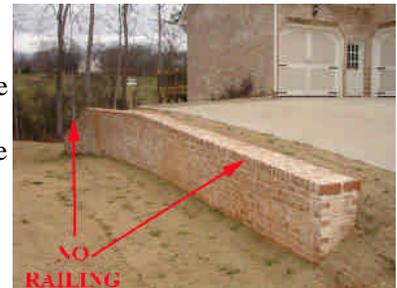
RETAINING WALL CONDITION: No guardrail installed on the top of the retaining wall (left side of driveway). The top of the wall is located more than 30" above the finished grade. Porches, balconies or raised floor surfaces located more that 30" above the floor or grade below should have guardrails not less than 36" in height (see CODE R316.1, 2000 Edition). *Note: A railing is installed on the front wall.*

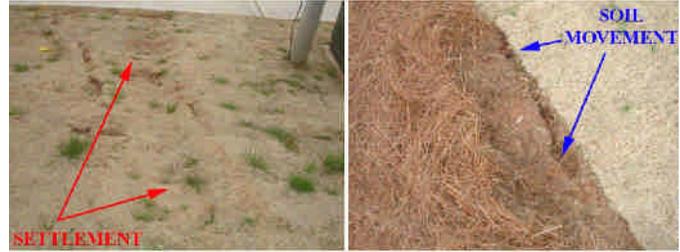
1. Soil settlement / movement noted. This is a good indication the soil was properly compacted. Backfill should be placed in 6" to 8" layers and tamped to consolidate the fill, to remove / prevent voids where water might collect.

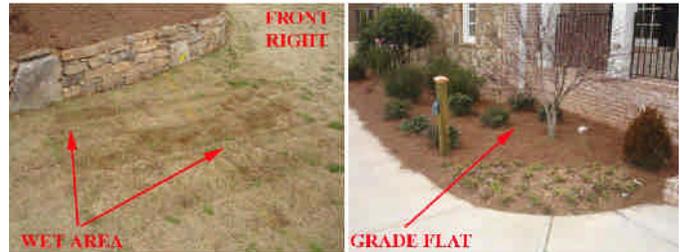
2. Very wet section of sod noted (*right side, below the lower retaining wall*). I was unable to determine what is causing this condition. It's

possible one or more of the sprinkler lines are damaged or leaking, further evaluation is needed.

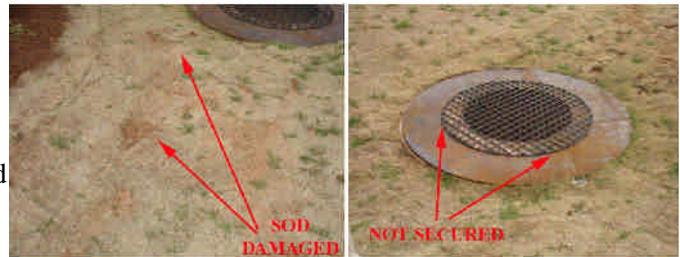
- 1. The sod around the storm drain is damaged, repair as needed.
- 2. The cover over the storm drain needs to be anchored in place. This is recommended for safety enhancement.

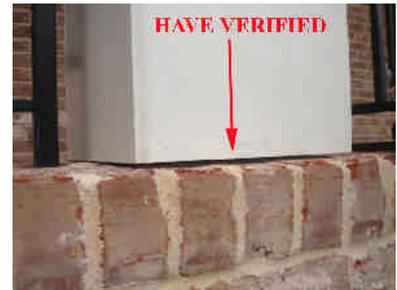
The vertical supports (*4x4's inside*) are not secured at the base. Vertical supports should be restrained to prevent lateral displacement at the bottom (see CODE R407.3, 2000 Edition).

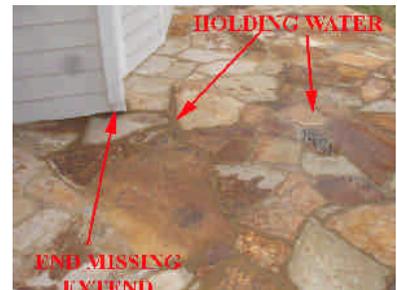
TYPE: Stone.
PATIO/PORCH
CON, CONDITION: *1. See termite comments.
2. Low areas noted, this condition will typically allow water to accumulate in heavy rains (standing water at time of the inspection). See gutter comments.*

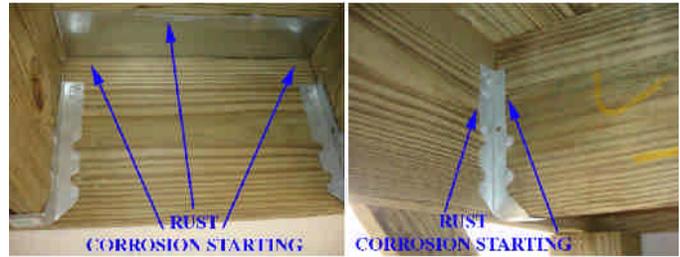
Rust and corrosion starting to accrue (bolts, joist hangers and flashing). The Environmental Protection Agency (EPA) banned chromated copper arsenate (CCA) as a preservative for wood intended for residential use (except for the lumber that is used in permanent wood foundations). Some of the new treated lumber products that are now being used are more corrosive than CCA, which means installers have to adjust their fastener and connector use to ensure that the metals do not rust or corrode. The switchover from CCA for most residential use officially began on Jan. 1, 2004. At that point, treatment manufacturers ceased production, although remaining inventories can still be stocked, sold, and installed until supplies run out. Builders across the country have switched from the treated lumber mainstay to new alternative treated products for decks, sill plates, and other applications. Taking CCA's place as a preservative are two waterborne compounds: alkaline copper quat (ACQ types B and D) and copper azole (CBA-A, CA-B). Sold under the trade names Preserve, Nature Wood, and Natural Select. These EPA-approved low-toxicity pesticides resist bugs, mold, and rot as effectively as CCA.

But while the new lumber has proven as effective against bugs and decay as CCA, testing shows that ACQ and copper azole are more corrosive than CCA, raising concerns about how fasteners and hardware will hold up over time. Before the official phase-out began, lumber treaters, fastener manufacturers, and other industry groups began ramping up efforts to educate installers, dealers, and the rest of the industry on the appropriate fasteners and hardware for the new materials. Generally, treatment manufacturers are recommending a minimum of stainless steel fasteners or hot-dipped galvanized fasteners that meet ASTM A153 standards and connectors that meet ASTM A653 Class G185 sheet or better, as well as fasteners tested and recommended by individual fastener manufacturers. See Southern Pine Advisory at the end of the report.

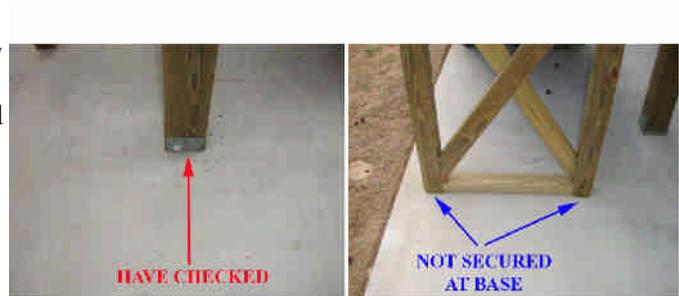
1. See deck condition, regarding deck fasteners.
2. The "4x4" vertical supports (*under the stairs*) are not secured at the base. Vertical supports should be restrained to prevent lateral displacement at the bottom (see CODE R407.3, 2000 Edition).

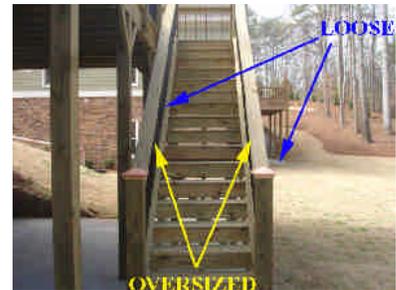
1. The handrail(s) are not the correct size. Handrails that are 2x4's or larger are difficult to grip. Handrails should have either a circular cross section with a diameter of 1 1/4" to 2", or a noncircular cross section with a perimeter dimension of at least 4" but not more than 6 1/4" and a largest cross section dimension not exceeding 2 3/4". Edges shall have a minimum radius of 1/8" (see CODE R315.2, 2000 Edition and GA Amendments).
2. The sturdiness of the handrail / guardrail needs further evaluated for safety. Guardrails and handrails should be able to withstand 200 pounds per square foot in any direction at any point along the top (see CODE Table R301.4, 2000 Edition).

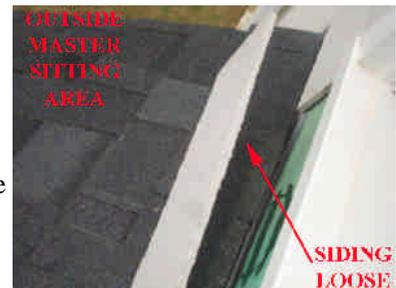
Loose section of siding noted, back wall (*outside master sitting area, below window*). All exterior walls should be covered with approved materials designed and installed to provide a barrier against the weather and insects to enable environmental control of the interior spaces (see CODE R703.1, 2000 Edition).

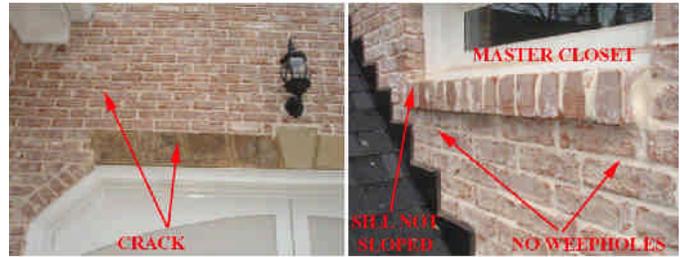
1. Cracks noted in the brick, left wall (above the back garage door). I recommend cracks be evaluated and repaired by a qualified contractor, after the repairs are performed recommend

monitoring all cracks in the future if cracks increase or reappear consult with a structural engineer.

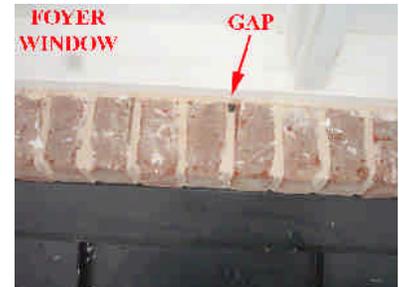
PAINT PHOTO:

1. Ladder marks noted on the wall, back (*above master bedroom window*).
2. Gap noted between the window sill and the brick, front wall (*foyer window*), seal as needed.

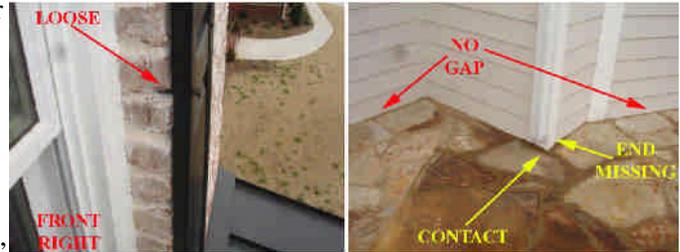
1. Section of trim damaged, double car garage (*back door, top*), replace as needed.
2. Loose shutter noted, front wall (*front right bedroom, right side*), repair as needed.
3. Some of the corner boards are in contact with the concrete, back porch (*condition conducive to termite infestation*). All lumber in contact with the foundation / slab should be pressure treated (see CODE R323.1 # 7, 2000 Edition). All wood trim should be a minimum of 6" above grade (see CODE R323.1 # 5, 2000 Edition). *Note: See termite comments.*

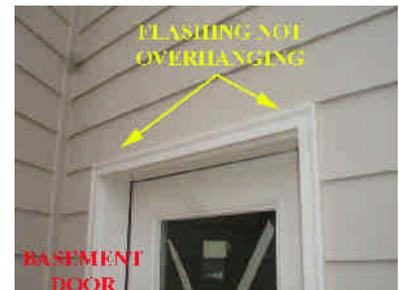
The flashing above the basement door was not installed properly. The flashing should extend out past the top edge of the door / window trim by 1/4" and turn down at a 45 degree angle. Approved corrosion-resistive flashing should be installed over the exterior doors and windows (see CODE R703.8,2000 Edition). *See other doors and window.*

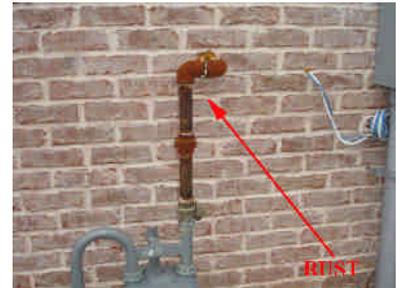
The gas meter is located on the right side of the home. Corrosion / Rust noted on the gas piping, next to the meter, prime/paint as needed with a paint suitable for metal. Aboveground outside piping should be protected from physical damage / corrosion by coating or wrapping with an inert material (see 404.7, Standard Gas Code).

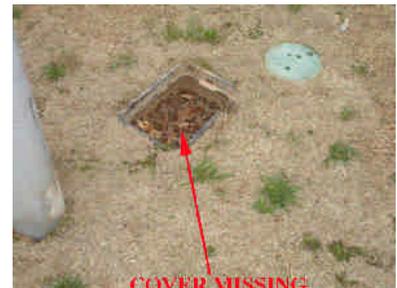
Front left side of driveway. The cover is missing off the meter, install as needed.

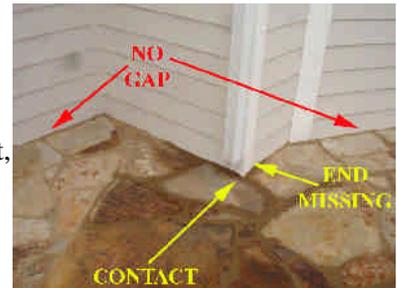
The wall cladding (*back porch*) is in contact with the concrete / stone (*no 2" space*). In areas favorable to termite damage as established by Table R301.2(1), methods of protection shall be by chemical soil treatment, pressure preservative treated wood in accordance with the AWPA standards listed in Section R321.1, naturally termite-resistant wood or physical barriers (such as metal or plastic termite shields), or any combination of these methods. Clearance between exterior wall cladding (except masonry veneer) and the top of the finished grade shall be at least 6 inches, and a 2 inch clear inspections space is required between the bottom of the wall cladding and the top of paved areas, e.g. driveway, footpath, patio (see CODE R324.1, and GA Amendments).

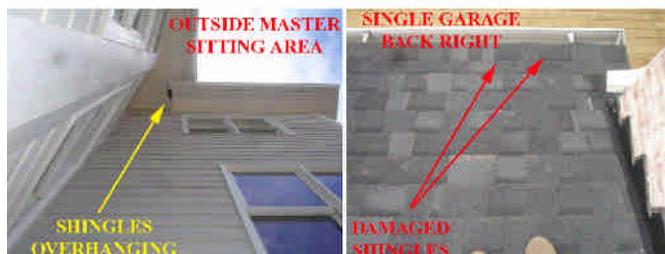
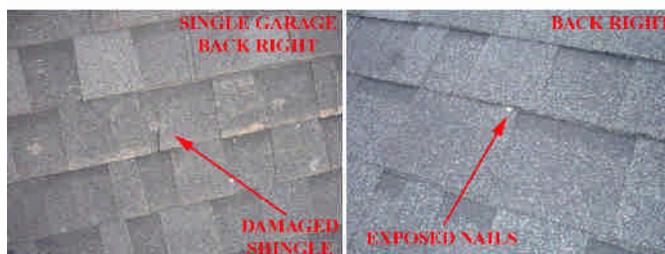
1. Some of the shingles are overhanging the fascia board, back (right side, outside the master sitting area).
2. Incorrect nailing noted, main roof (back right, next to ridge, exposed nails heads). Some of the nail(s) are not being protected / covered by the upper adjacent course of shingles. A minimum of four nails per shingle is recommended. Two of the nails should be placed approximately 1" in from each end; the other two should be placed directly (5/8") above the center of each cut-out (see CODE R905.2.5 / R905.2.6, 2000 Edition or Manufacturer's printed instructions). I recommend the entire roof area be checked for incorrect nailing of the shingles.

3. Damage / cracked shingles noted, roof above the single garage (back right). Damaged shingles could turn into a roof leak. All damaged shingles should be replaced. Roof shingles should provide a barrier against the weather to protect its supporting elements and structure beneath (see CODE R903.1, 2000 Edition).

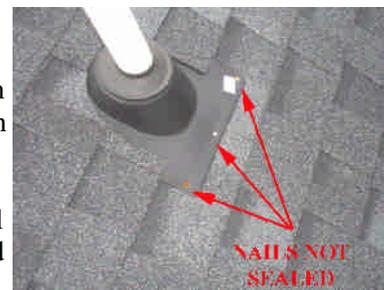
Nails noted in the exposed areas of the flashing, roof vent(s), furnace vent(s), plumbing vent(s). Nails should not be used in the exposed areas of the flashing. If and when nails are used, the nail heads should have asphalt plastic cement applied over them. Flashing against vertical walls, as well as soil stack, vent pipe and chimney flashing, should be applied according to asphalt shingle manufacturer's printed instructions. Flashing should be installed in such

manner as to prevent moisture from entering (see CODE R903.2, 2000 Edition or the shingle Manufacturer's printed instructions).

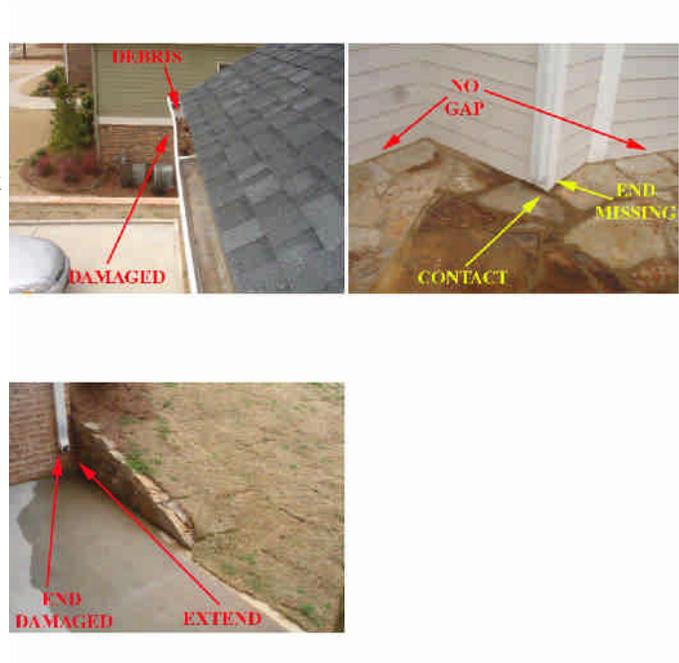
GUTTER CONDITION: 1. Debris in gutter(s), recommend having the gutters cleaned.
2. End missing off the downspout, back right corner. See back porch comments.
3. Damaged section of gutter, front (above the single garage, left side), replace as needed.
4. I recommend routing all the downspouts away from the building. This will help with drainage around the foundation.

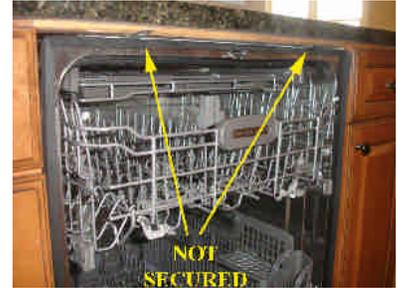
The dishwasher is not secured to the counter top, repair as needed.

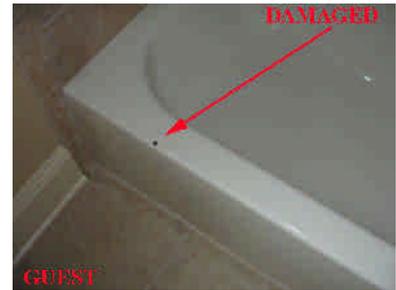
TUB/SHOWER AND WALLS: The tub is damaged / chipped, guest bathroom, repair / replace as needed.

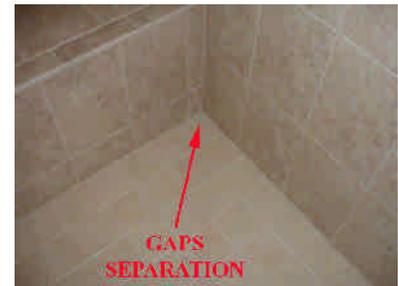
Caulking and/or re-grouting is needed to prevent water intrusion, master tub and shower area (Refer to page 23 in the Home Maintenance book).

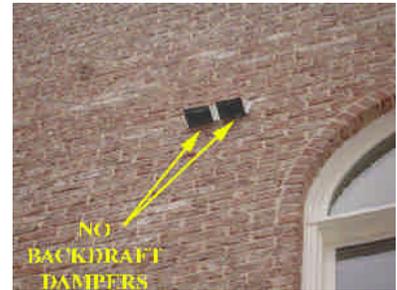
No backdraft dampers installed (*exterior section, left wall*). All exhaust vents should be equipped with a backdraft damper (see CODE R303.3,2000 Edition).

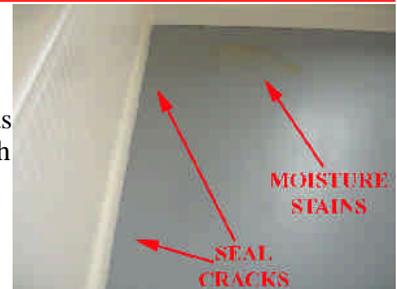
STAIN GARAGE: Moisture stains noted on the floor of the double car garage (*front right*). The stains were dry at the time of the inspection. However, the stain are an indication there was a leak in the past, I recommend inquiring with the builder regarding the stains.

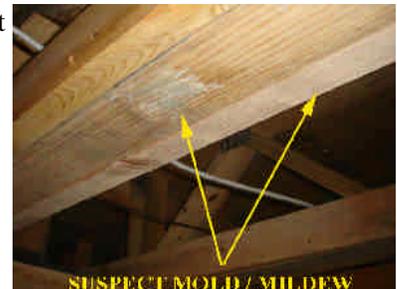
2. Suspect mold / mildew noted, basement area (*along the bottom of some of the floor joist, check all areas*). Some people are sensitive to mold / mildew and experience headaches, runny noses, skin rashes, nausea, sinus problems. The U.S Environmental Protection Agency has created a publication to provide information and guidance for homeowners and renters on how to clean up residential mold problems and how to prevent mold growth. The publication is titled Brief Guide to Mold, Moisture and Your Home and can be found on the Web site at www.epa.gov/iaq/molds/moldguide.html. Due to the health hazards relating to mold / mildew, I recommend it be tested by a qualified industrial hygiene company to determine the type of mold and the hazards relating to it (*Mold / Mildew testing is beyond the scope of this inspection*). After testing appropriate steps should be taken to correct the mold / mildew condition within the home.

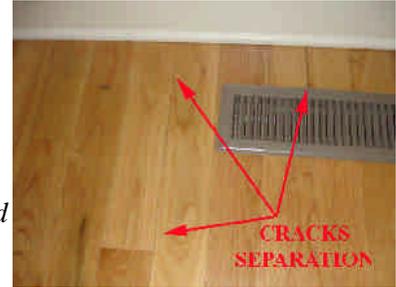
FLOOR TYPE: Carpet, Wood.
FLOOR CONDITION: 1. Scratches noted in some areas of the wood flooring, repair as needed.
2. Crack's and separation noted in some sections of the wood flooring, front entrance, and hall, repair as needed. *Note: Hardwood floors will fluctuate some due to temperature differences. However, gaps should not exceed 1/8".*
3. The wood floors appear to need one more coat of finish, apply as needed.

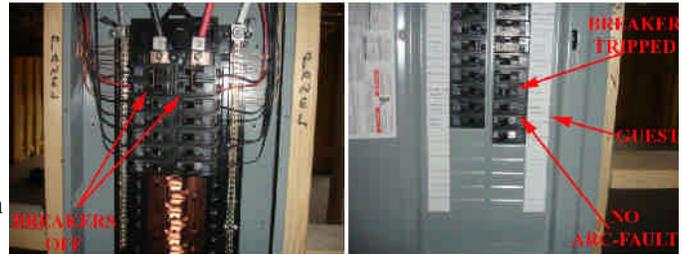
1. Some of the breakers were in the off position at the time of the inspection, and the upstairs hallway / attic breaker was tripped. Have reason verified by a licensed electrician.

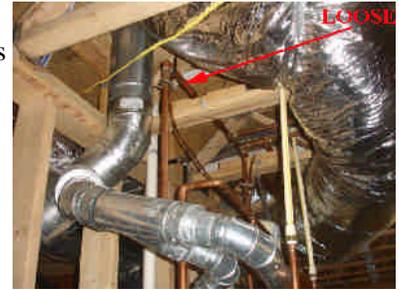
Loose clamp noted, hot / cold water lines (above water heaters). Grounding conductors and bonding jumpers shall be connected by exothermic welding, listed pressure connectors, listed clamps, or other listed means (see NEC 250.8, 250.102(B), 2002 Edition).

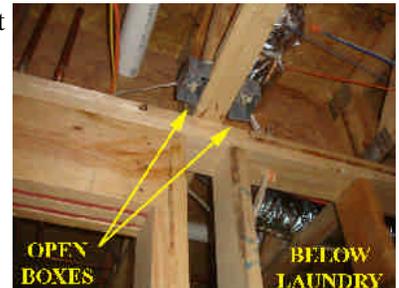
Open junction boxes, basement area front left (below the laundry, back wall). All boxes should have a cover, faceplate, or fixture canopy (see NEC 314.25, 2002 Edition).

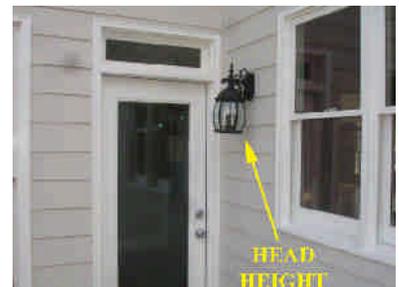
1. No light fixture installed, front left bedroom, install as needed.
2. Adjustments needed to the light fixture in the master bathroom (front sink), repair as needed.
3. The switch to turn on the light fixtures above the double car garage is located in the "single" car garage.
4. Lights are not operational in some areas, single car garage, possibly due to bad bulbs or no bulbs, have them checked.
5. The light fixture outside the back door (deck level) is low. It depends on the fixture how high it should be. However, 66" is recommended from the top of the deck to the center of the mounting box. Note: If the fixture is "downward"

from the box on fixture, the box should be mounted higher.

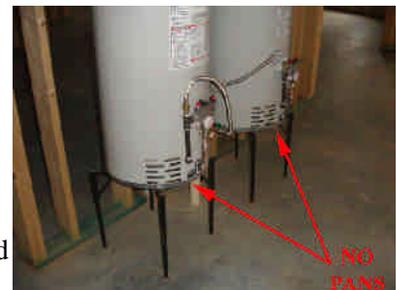
No catch pans installed under the water heaters. When water heaters or water storage tanks are installed in attics, above ceilings or in habitable areas (where tank leakage could cause damage). **Note:** at some point in the future the basement area will be finished). A galvanized steel pan having a minimum thickness of 24 gauge, or other pans approved for such use should be installed under the water heater (see 504.7, Georgia State Amendments to the Standard Plumbing Code).

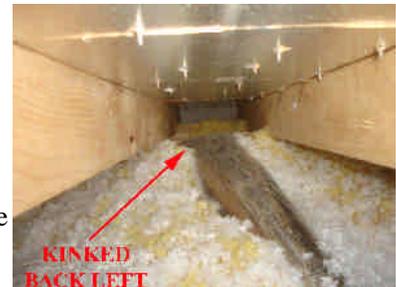
DUCTWORK TYPE:	Flexible Round, Insulated sheet metal.
DUCTWORK CONDITION:	The ductwork was poorly installed in some areas, main attic (<i>back left above the master bedroom, kinks noted</i>), check all sections. The flexible duct runs should be installed as straight as possible and they should be cut to length. Kinked turns, coils and loops will create unnecessary pressure losses and reduce air flow. See flexible ductwork installation standards at the end of the report.

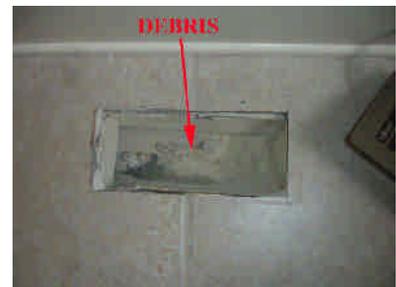
REGISTERS / AIR SUPPLY:	Debris noted in the construction registers, clean as needed.
-------------------------	--

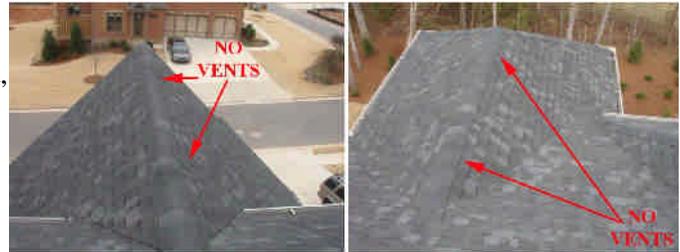
No vents provided in the upper portion of the attic above the "front" master closet, master sitting area, and single garage. The total net free ventilating area should not be less than 1 to 150 of the space ventilated except that the total area is permitted to be reduced to 1 to 300, provided at least 50 percent and not more than 80 percent of the required ventilation area is provided by ventilators located in

the upper portion of the space to be ventilated at least 3 feet above eave or cornice vents with the balance of the required ventilation provided by eave or cornice vents (see CODE R806.2, 2000 Edition). *In my opinion ridge vents would function best in these areas.*

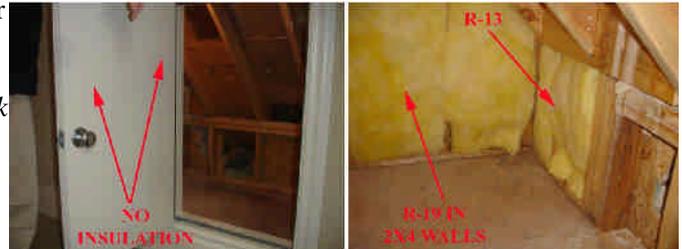
1. Sections of insulation missing or loose, attic / storage area off the master closet (*left side, back wall*), main attic (*under plywood platform, area next to the pull down stairs*).

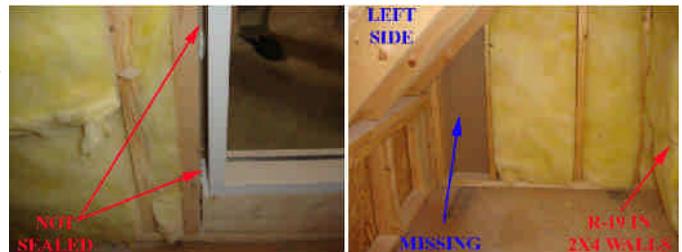
2. Only R-19 batts installed in the "flat" ceiling area above the master bathroom (*front area*). Have the right and left areas above the master sitting area checked for R-30 batts.

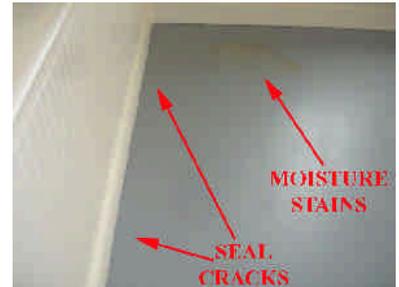
FLOOR
 CONDITION: Cracks noted in the exposed floor area. I recommend cracks be sealed and monitored for further movement. If cracks reappear or get larger, consult with a structural engineer.

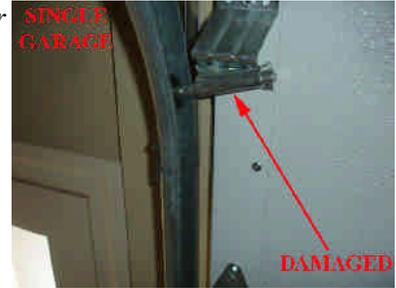
Appears serviceable.
The two "top" rollers are damaged (*single car garage*), replace / repair as needed.

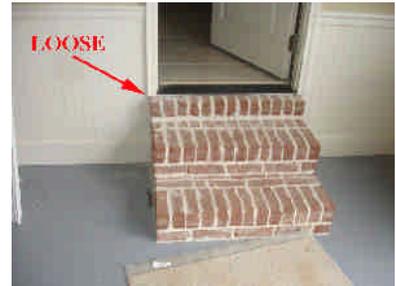
Wood.
Appears serviceable.
Not Visible.
Not Visible.
Not Visible.
Not Visible.
Loose bricks noted, single car garage, repair as needed.

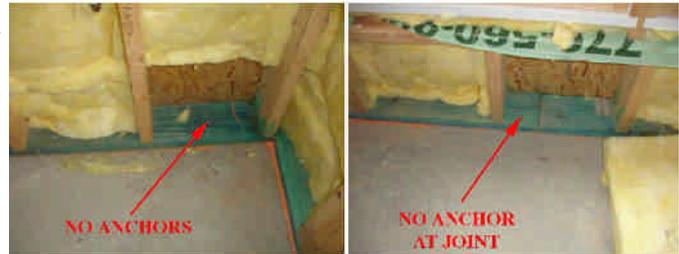
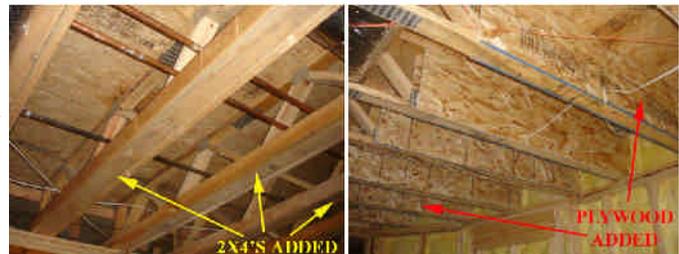
HEADER TYPE:	Wood.
HEADER CONDITION:	Appears serviceable.
FLOOR JOISTS/ TYPE:	Open-Web Trusses, 16" @ 24" O/C.
OPEN-WEB TRUSS CONDITION:	<p>1. See mold / mildew comments.</p> <p>2. The floor joist below the family room have 2x4's and plywood added to the sides. Generally, when trusses are cracked or damaged this is a common repair. I was unable to locate any damaged or cracked trusses. However, I recommend you inquire with the builder or with the floor joist manufacturer as to why the plywood and 2x4's were added.</p>
