DUFFY HOME INSPECTION SERVICE, INC.

DATE OF INSPECTION: 0-00-2006.
TIME OF INSPECTION: 12:30 noon.
CLIENT NAME: Mr. Mat Jones.
PHONE #: 404-000-5555.
E-MAIL ADDRESS: euwww@comcast.com.

000 Jones Drive.

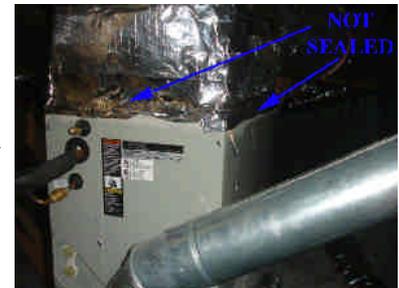
UNIT/UNITS HEATING NOTES:	Appears operational.
BURNERS/HEAT EXCHANGERS:	Closed System - Unable to visually inspect the heat exchanger.
PUMP/BLOWER FAN:	Appears serviceable.
COMBUSTION AIR:	Appears serviceable.
FURNACE VENTING:	Appears serviceable.
AIR PLENUM:	Unit 1 (master bedroom): Some of the joints have been sealed tape which is known to peel off over time (some of the tape is peeling). Mastic is needed over the tape to prevent peeling. <i>All</i> joints should be securely fastened and sealed with welds, gaskets, mastic adhesives, mastic-plus-embedded-fabric systems or tapes (see Standard Mechanical Code 603.8). <u>Duct tape is not permitted as a sealant on any ducts</u> (see International Energy Conservation Code 503.3.3.4.3 with Georgia Supplements and Amendments).
AIR FILTERS TYPE / CONDITION:	Washable, Appear serviceable.
AIR FILTER LOCATION(S):	In the blower compartment of the furnace.
NORMAL CONTROLS:	Appear serviceable.

GENERAL SUGGESTIONS:	I recommend having your system service annually (indoor / outdoor units) by a licensed Heating and Air Conditioning contractor - change filter(s) every 30 to 60 days. For more information on filters (see page 28, in the Home Maintenance book).

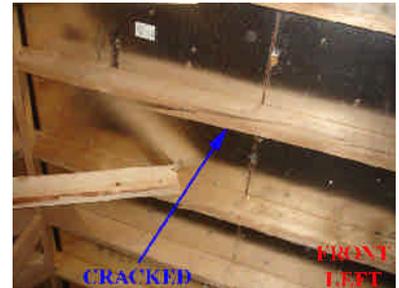
ATTIC ENTRANCE LOCATION:	Hallway, upstairs, Closet, upstairs, Garage.
ACCESSIBILITY:	Pull down stairs, Doors.
METHOD USED TO OBSERVE:	Entered Accessible areas, attic insulation restricted viewing.
ATTIC FRAMING TYPE:	Conventional framing, Rafter Framing, 2X6 @ 16" O/C, Joist Framing, 2X8 @ 16" O/C.
FRAMING CONDITION:	Cracked rafter noted, main attic (<i>left side, above the master bathroom</i>). I recommend adding additional support. Roof framing should be capable of supporting all loads imposed and should transmit the resulting loads to its supporting structural elements (see CODE R801.2,2000 Edition).
PURLIN CONDITION:	Appears serviceable.
STRUTS CONDITION:	Appears serviceable.
ROOF SHEATHING:	Appears serviceable.
FIRE STOPPING:	Visible areas appear serviceable.

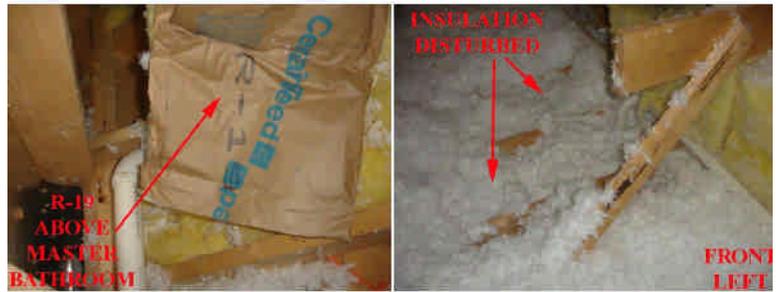
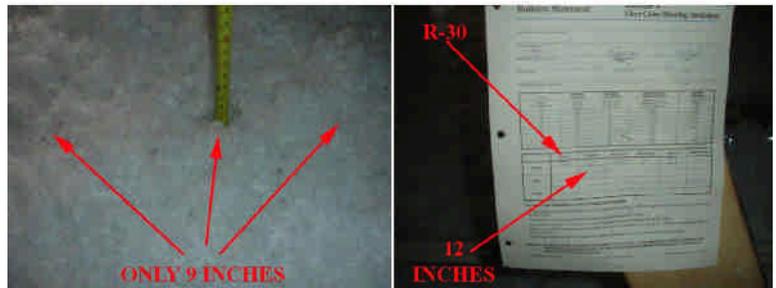
INSULATION
CONDITION:

1. Sections of insulation missing or loose, attic / storage area off the master closet (*left side, back wall*), main attic (*under plywood platform, area next to the pull down stairs*).

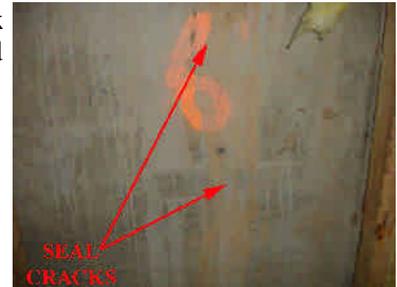
Cracks noted in the exposed wall area (**check all areas**). I recommend cracks be sealed and monitored for further movement. If cracks reappear or get larger, consult with a structural engineer.

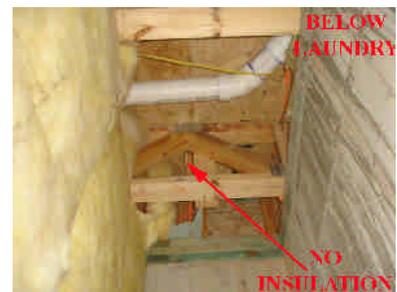
BASEMENT
INSULATION:

Installed, in the wall(s).
Areas with no insulation installed, front left (*below laundry*), right side (*area below the living room*), install as needed (check the entire basement area), (see International Energy Conservation Code 502.2.2.1.6, 602.1.5, with Georgia Supplements and Amendments, Table 502.2.1).

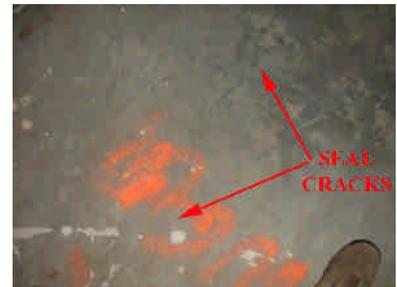
BASEMENT FLOOR
CONDITION:

Cracks noted in the exposed floor area. I recommend cracks be sealed and monitored for further movement. If cracks reappear or get larger, consult with a structural engineer.
